**TABLE OF OBSERVED FEATURES
 SURVEY AREA 5
 PROFILE HOUSE BRANCH
 MUCHMORE ROAD, BETHLEHEM TO
 US ROUTE 3, BETHLEHEM**

**PHOTOGRAPHS
SURVEY AREA 5
PROFILE HOUSE BRANCH
MUCHMORE ROAD, BETHLEHEM TO
US ROUTE 3, BETHLEHEM**

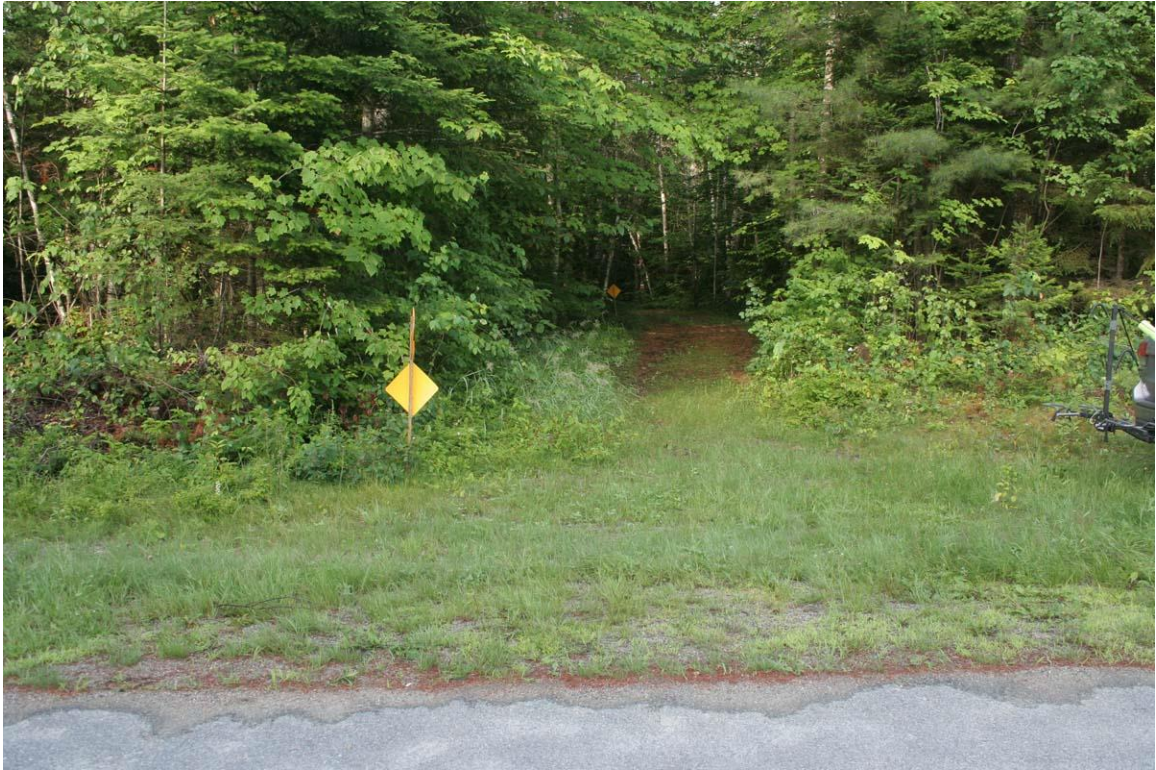
Photo ID #: S5_1444 Direction: S Date: 7/18/2019 Image stored at: HDC

Photo # 1 description: Entrance to ROW/ Profile Recreational Trail off Muchmore Road, Bethlehem, west of Pierce Bridge. No evidence of ROW or resources between this point and the main line on north side of Ammonoosuc R. NOTE: Mile points are unknown.

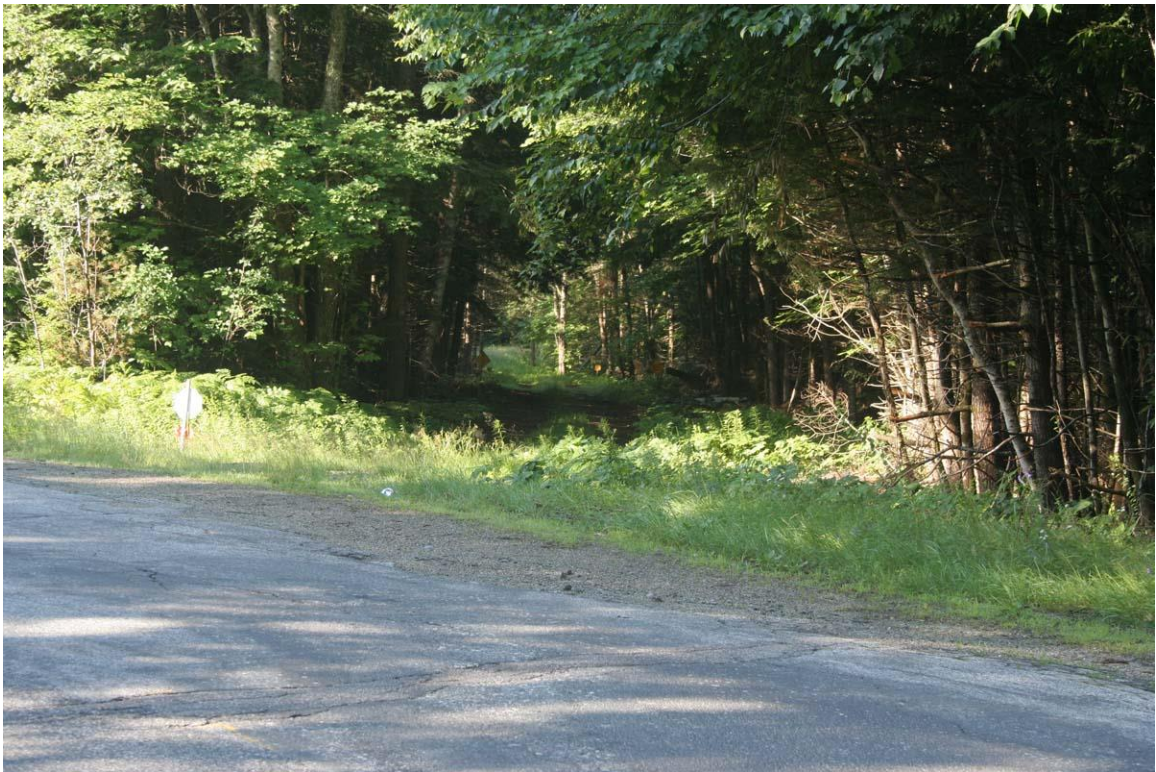
Photo ID #: S5_1445 Direction: S Date: 7/18/2019 Image stored at: HDC

Photo # 2 description: Entrance to ROW/Trail off Trudeau Road, Bethlehem. No ROW resources are located on the 1400' section between Muchmore Rd and Trudeau Rd.

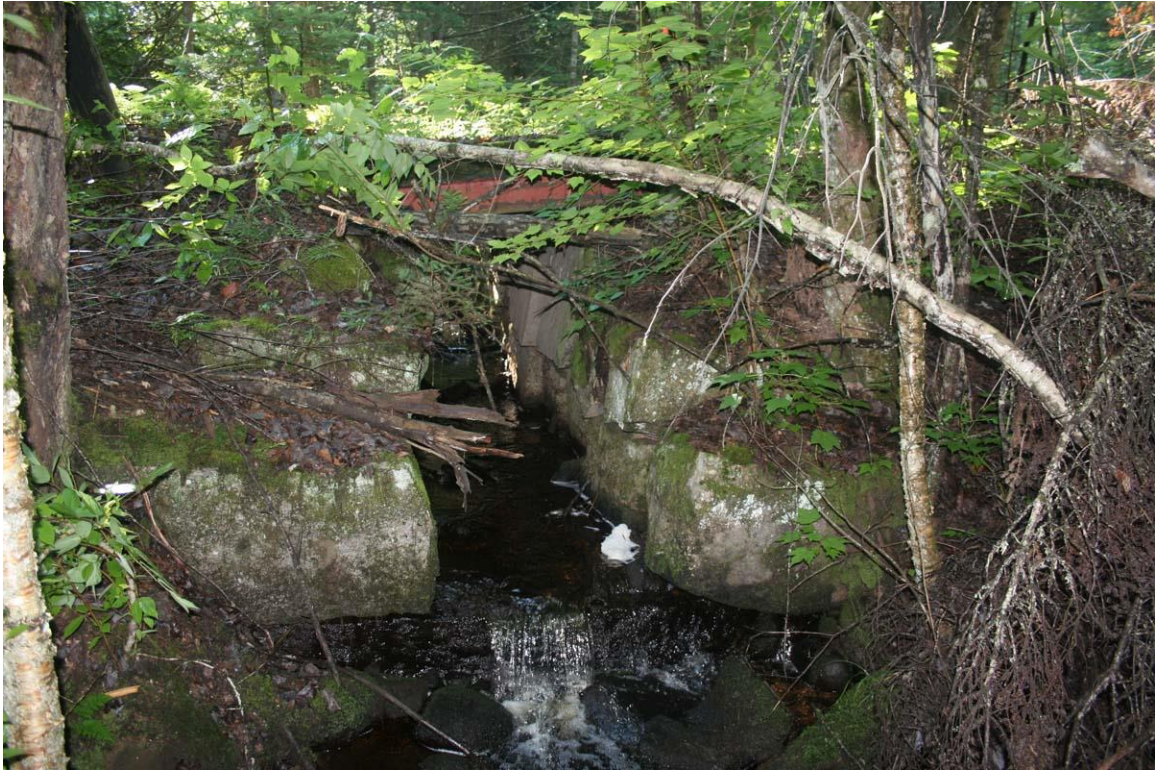
Photo ID #: S5_1446 Direction: W Date: 7/18/2019 Image stored at: HDC

Photo # 3 description: B&M Bridge 222a, Bethlehem. 500' south of Trudeau Rd. crossing. Wood stringer on split fieldstone abutments, ~ 3' span. nd.

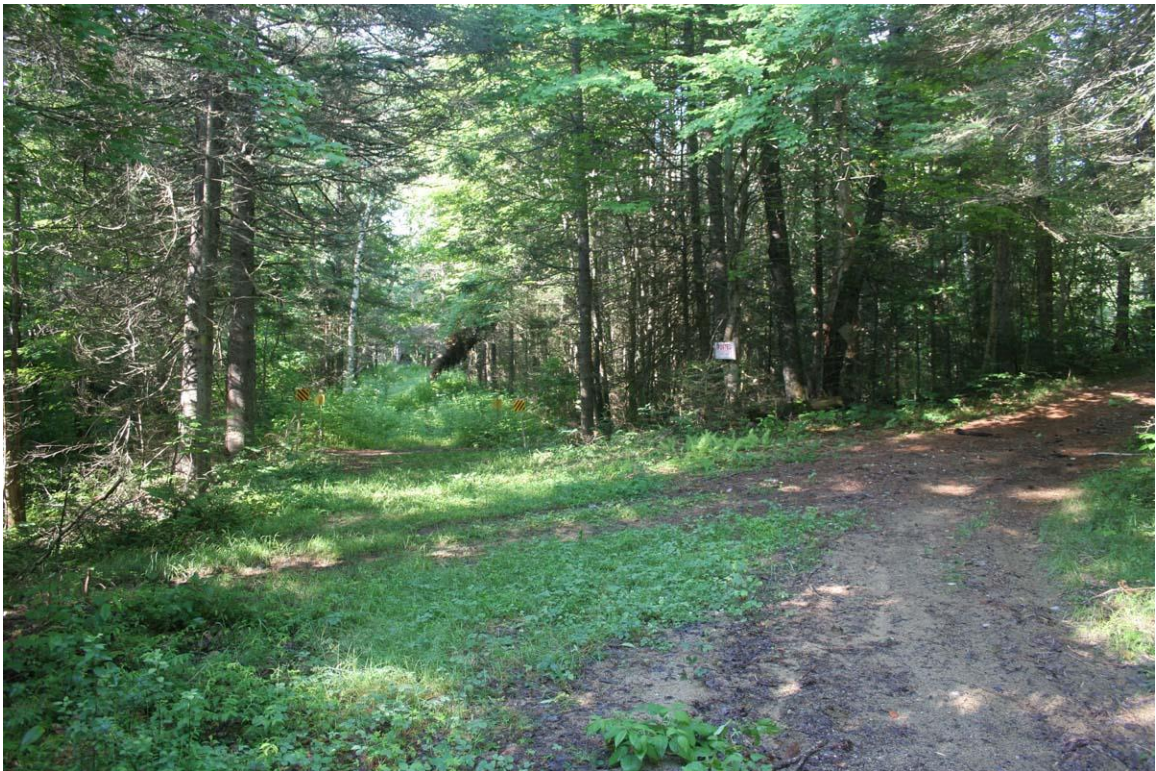
Photo ID #: S5_1448 Direction: S Date: 7/18/2019 Image stored at: HDC

Photo # 4 description: Character of ROW 2700' south of Trudeau Rd. crossing, Bethlehem. Junction with private trail running east-west.

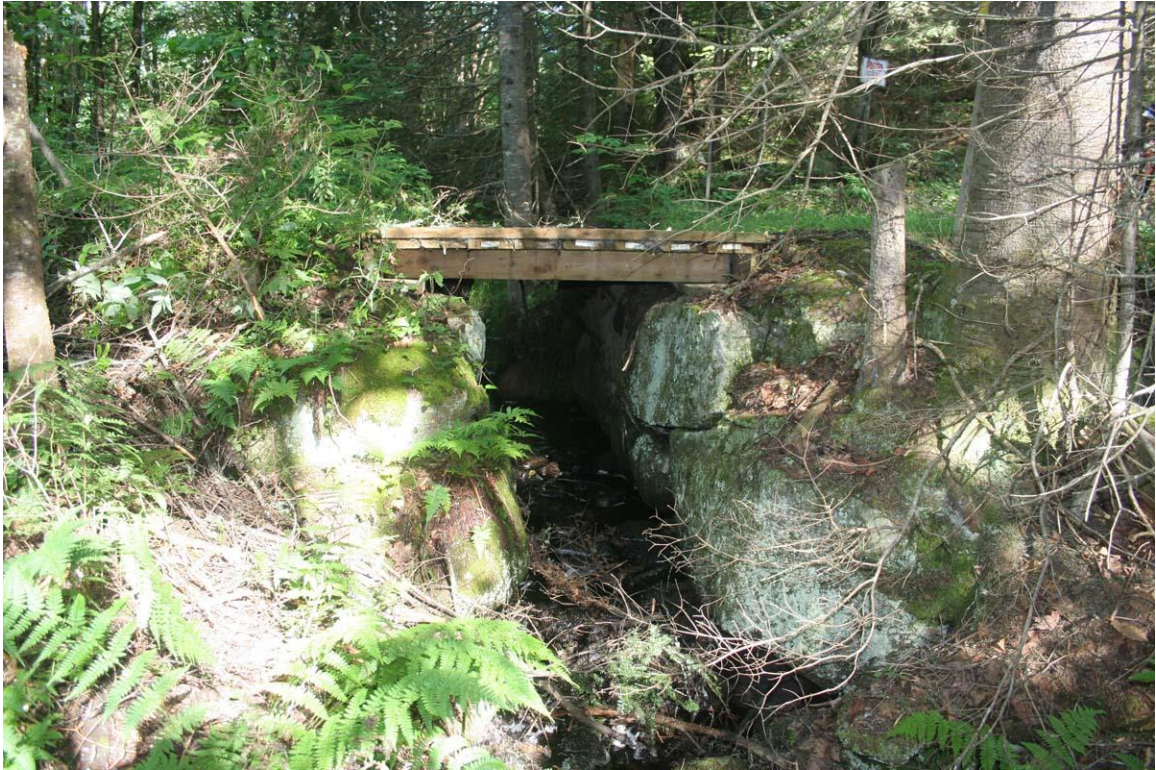
Photo ID #: S5_1449 Direction: W Date: 7/18/2019 Image stored at: HDC

Photo # 5 description: B&M Bridge 222b, Bethlehem. 2750' south of Trudeau Rd. crossing. Wood stringer (recently rebuilt) on split fieldstone abutments, ~4' span. nd.

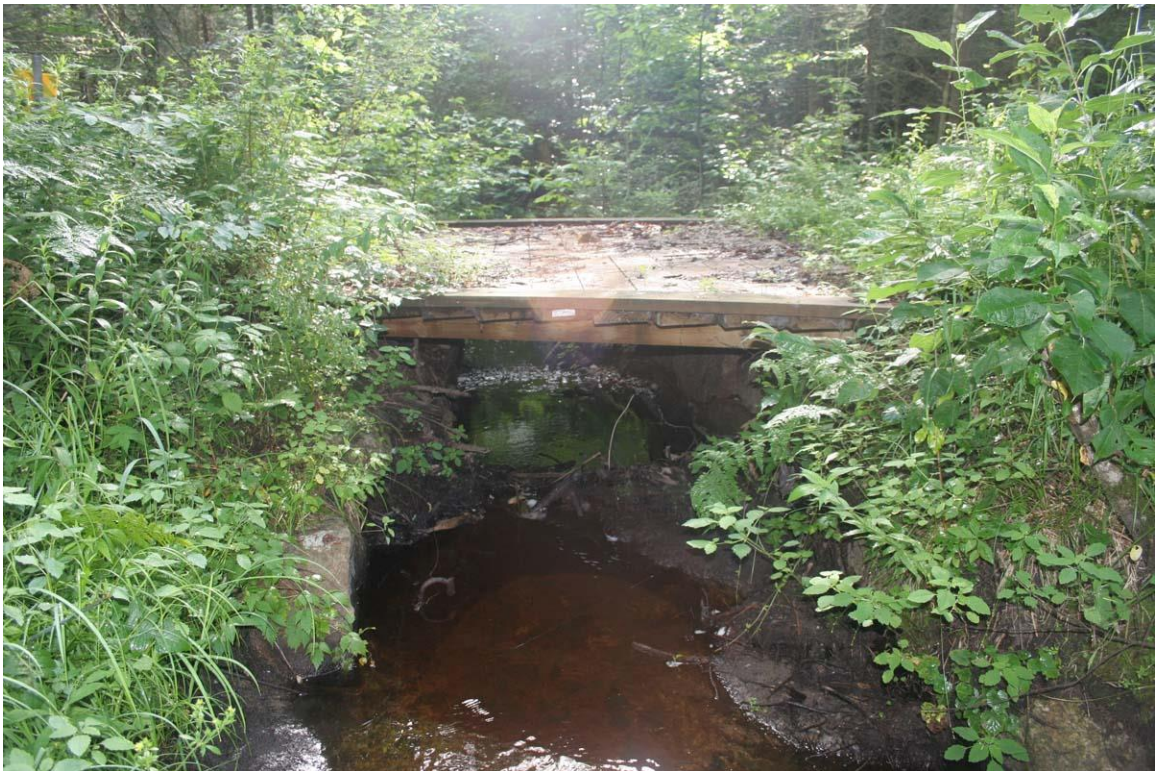
Photo ID #: S5_1451 Direction: W Date: 7/18/2019 Image stored at: HDC

Photo # 6 description: B&M Bridge 222c, Bethlehem. 3100' south of Trudeau Rd. crossing. Wood stringer (recently rebuilt) on split fieldstone abutments, ~5' span. nd.

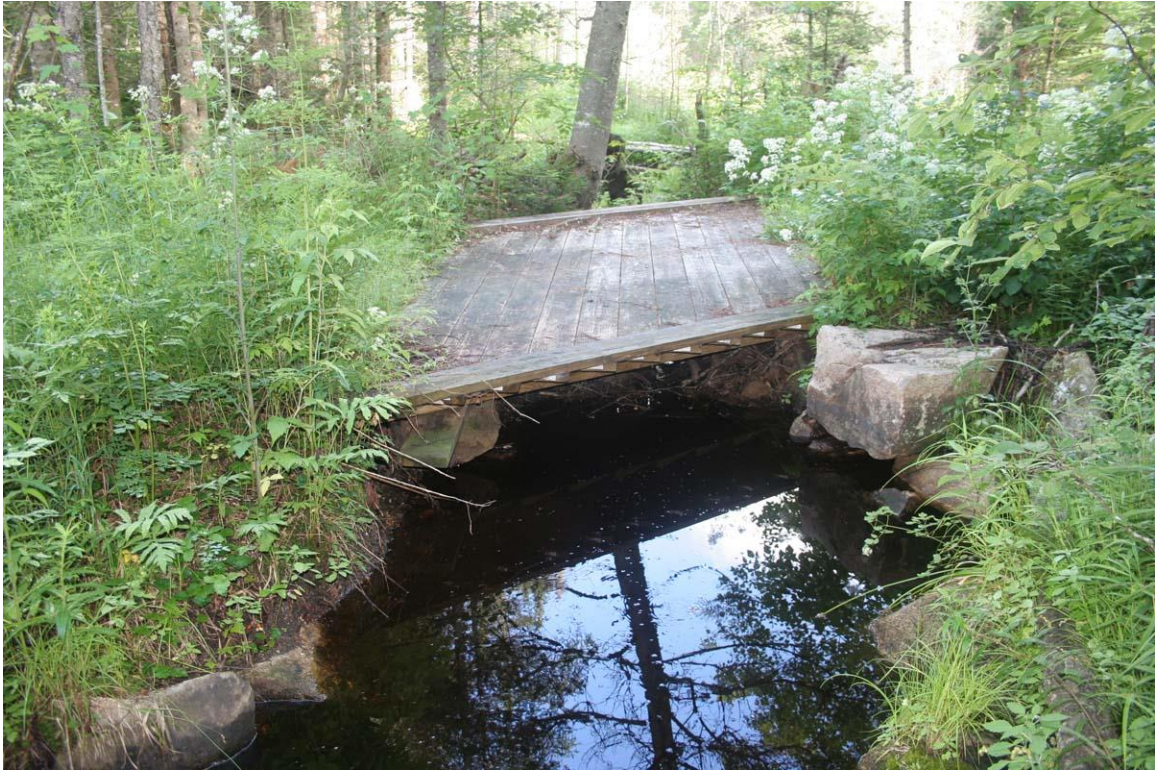
Photo ID #: S5_1453 Direction: W Date: 7/18/2019 Image stored at: HDC

Photo # 7 description: B&M Bridge 222, Bethlehem. 3350' south of Trudeau Rd. crossing. Wood stringer (recently rebuilt) on rebuilt split fieldstone abutments, ~8' span. nd.

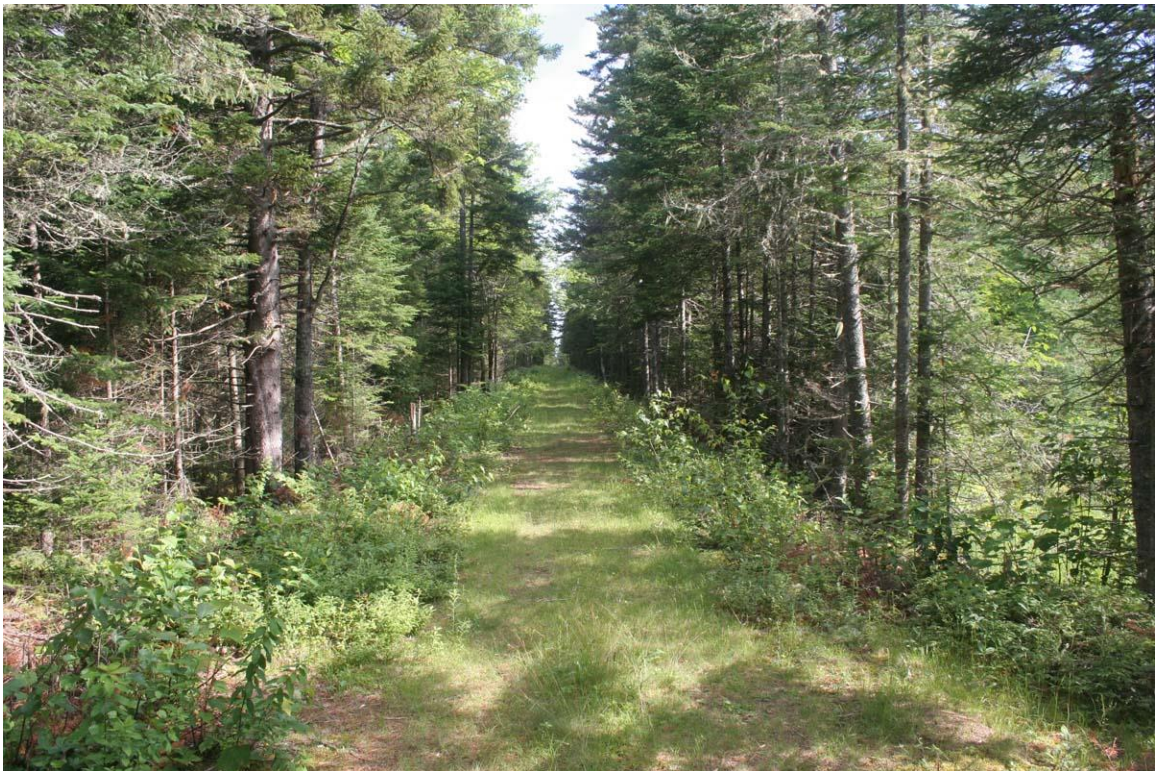
Photo ID #: S5_1454 Direction: S Date: 7/18/2019 Image stored at: HDC

ROW	*	Bethlehem	C	8	?	Character of ROW ~7500' south of Trudeau Rd. Straight, level, substantially raised railbed makes this identifiable as a railbed to most observers.
Beaver Brook Bridge, Profile Recreational Trail	*	Bethlehem	N/C	9	?	New trail bridge.
ROW	*	Bethlehem	N/C	10	?	Character of ROW 700' north of US 3.
ROW crossing US 3	*	Bethlehem	N/C	11	?	No evidence of railroad resources.

Photo # 8 description: Character of ROW 7500' south of Trudeau Rd. crossing, Bethlehem. 50' north of Beaver Brook bridge. Location of Beaver Brook overflow; consisting of two new 48" CMP culverts.

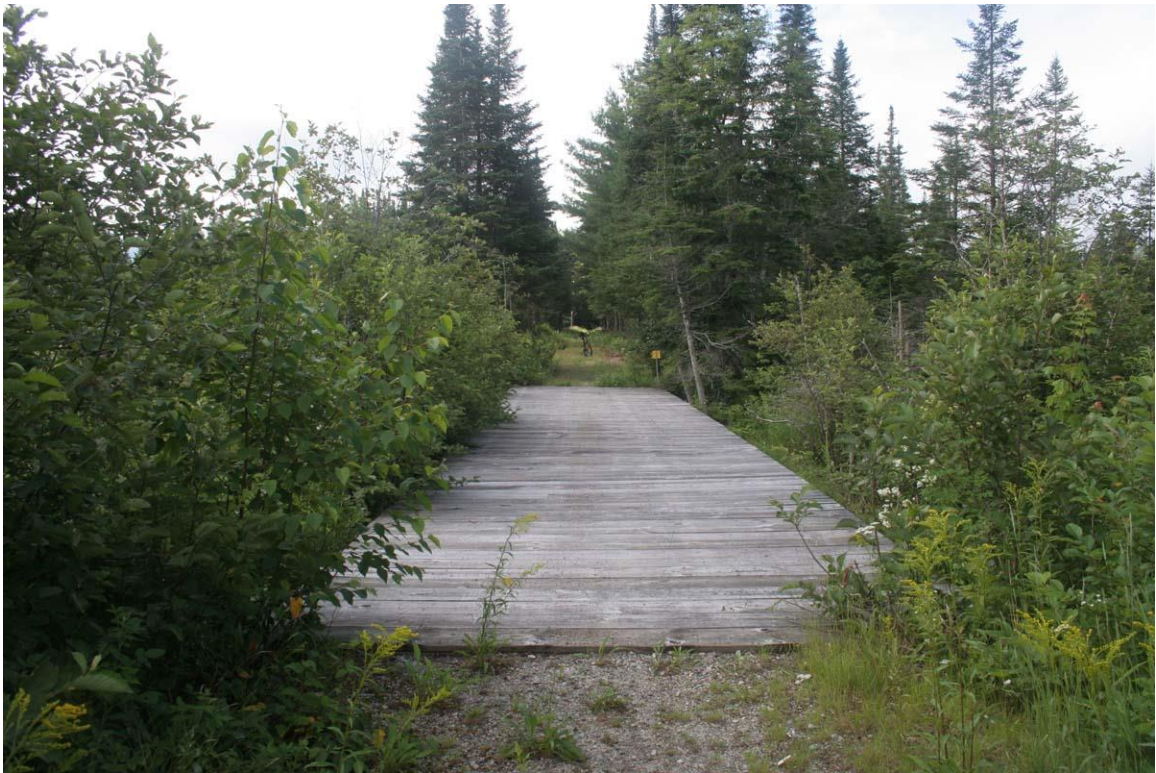
Photo ID #: S5_1455 Direction: S Date: 7/18/2019 Image stored at: HDC

Photo # 9 description: Beaver Brook Bridge, Profile Recreational Trail, Bethlehem. Newly constructed trail bridge on new stone abutments; probably utilized some split fieldstone from previous bridge.

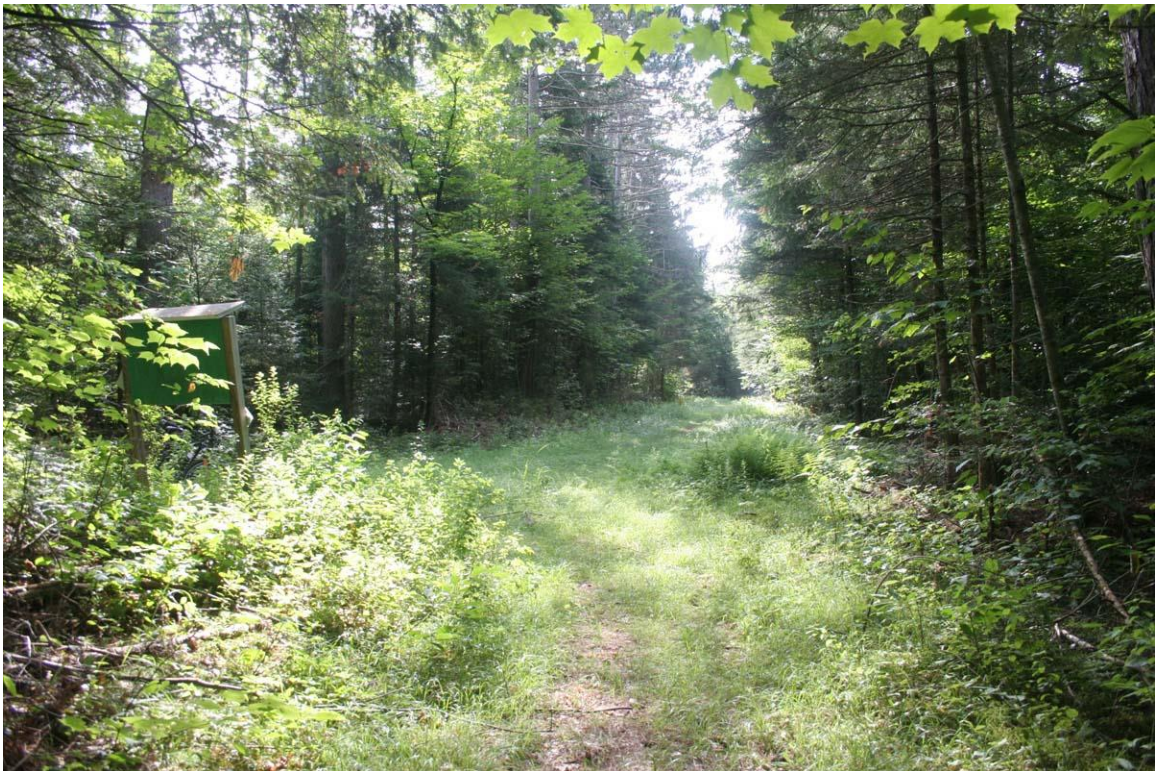
Photo ID #: S5_1456 Direction: N Date: 7/18/2019 Image stored at: HDC

Photo # 10 description: Character of ROW 700' north of US 3, Bethlehem. Junction with Gale River Trail running east-west. Note trail sign at left. ROW continues south but impassable.

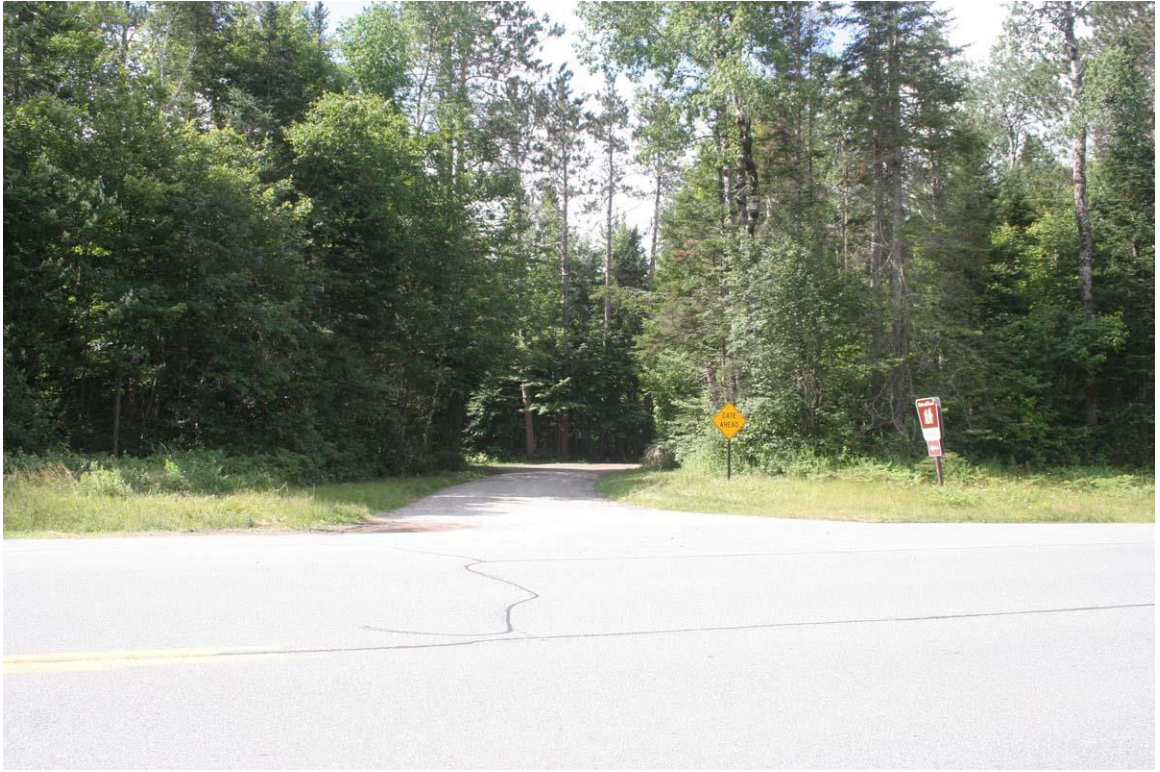
Photo ID #: S5_1462 Direction: S Date: 7/18/2019 Image stored at: HDC

Photo # 11 description: Location of former ROW crossing US 3 at entrance to Gale River Loop Road in White Mtn. National Forest, Bethlehem. ROW then curves west and follows US 3 which was built on the ROW to Profile House, Franconia. No evidence of ROW remains south of this point.
